Interim Report

Type of Occurrence:	Accident
Date:	7 January 2017
Location:	Enroute, above the Arabian Sea
Aircraft:	1) Airplane 2) Airplane
Manufacturer / Model:	1) Bombardier / CL-600-2B16 (604 Variant) 2) Airbus / A380-861
Injuries to Persons:	1) Two severely injured passengers, two passengers and one flight attendant suffered minor injuries 2) None
Damage:	1) Aircraft severely damaged 2) None
Other Damage:	None
State File Number:	BFU17-0024-2X
Published:	May 2017

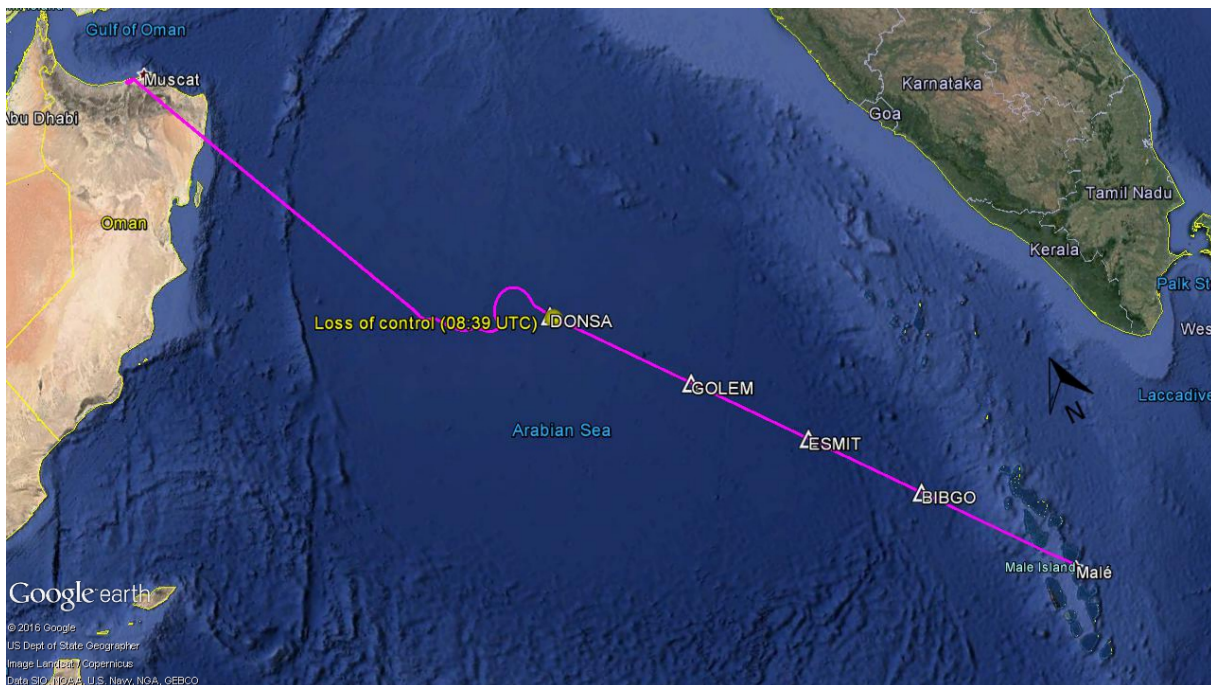
Reconstruction of the CL604 flight path (according to FDR data)

Using FDR data the flight path of the CL604 was reconstructed.

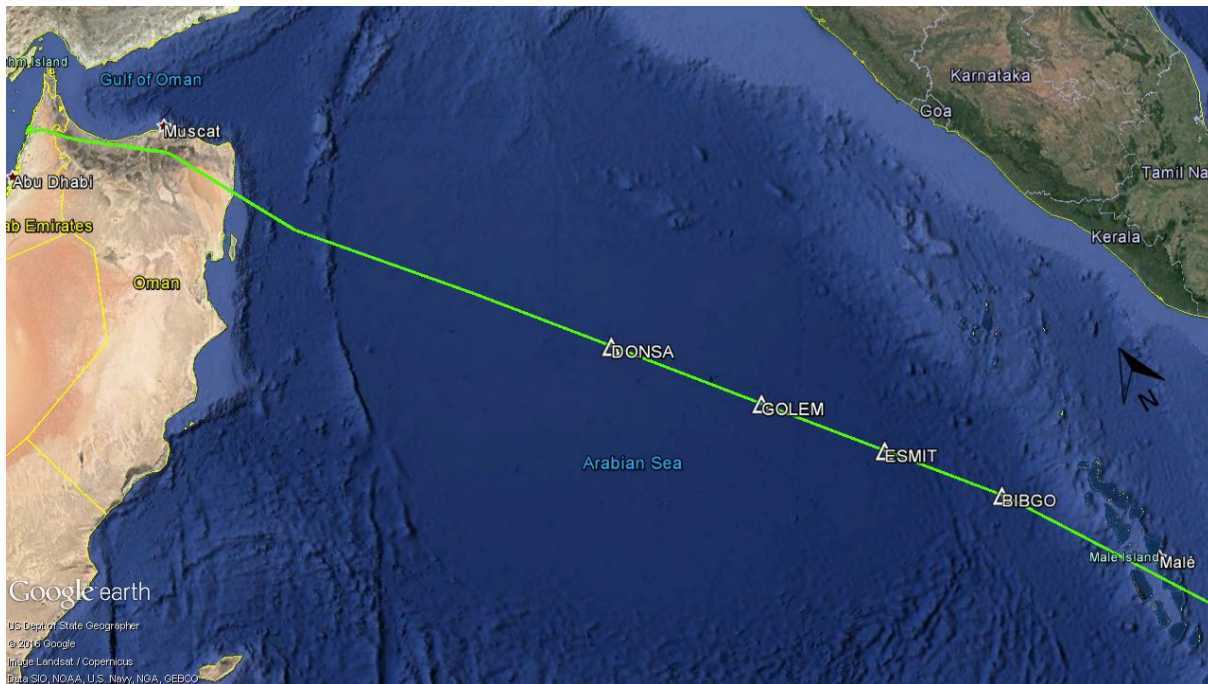
Reconstruction of the A380 flight path (according to DAR data)

Using DAR data the flight path of the A380 was reconstructed.

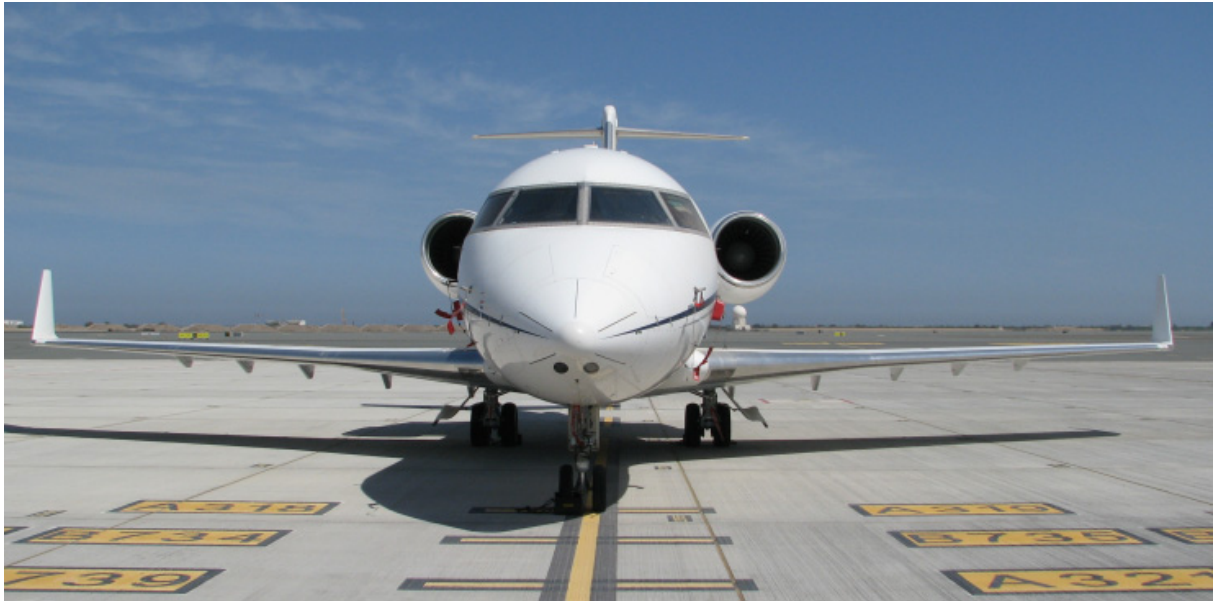
Outer condition of the airplane

The aircraft manufacturer determined that the airframe structure could not be restored to an airworthy state as it exceeded the airframe certification design load limits during the upset encounter. Therefore the aircraft is considered to be damaged substantially.

During a BFU investigation of the airplane no outer damages on fuselage, wings, and empennage, including control surfaces, were visible. There was no evidence of leakages (oil, fuel).

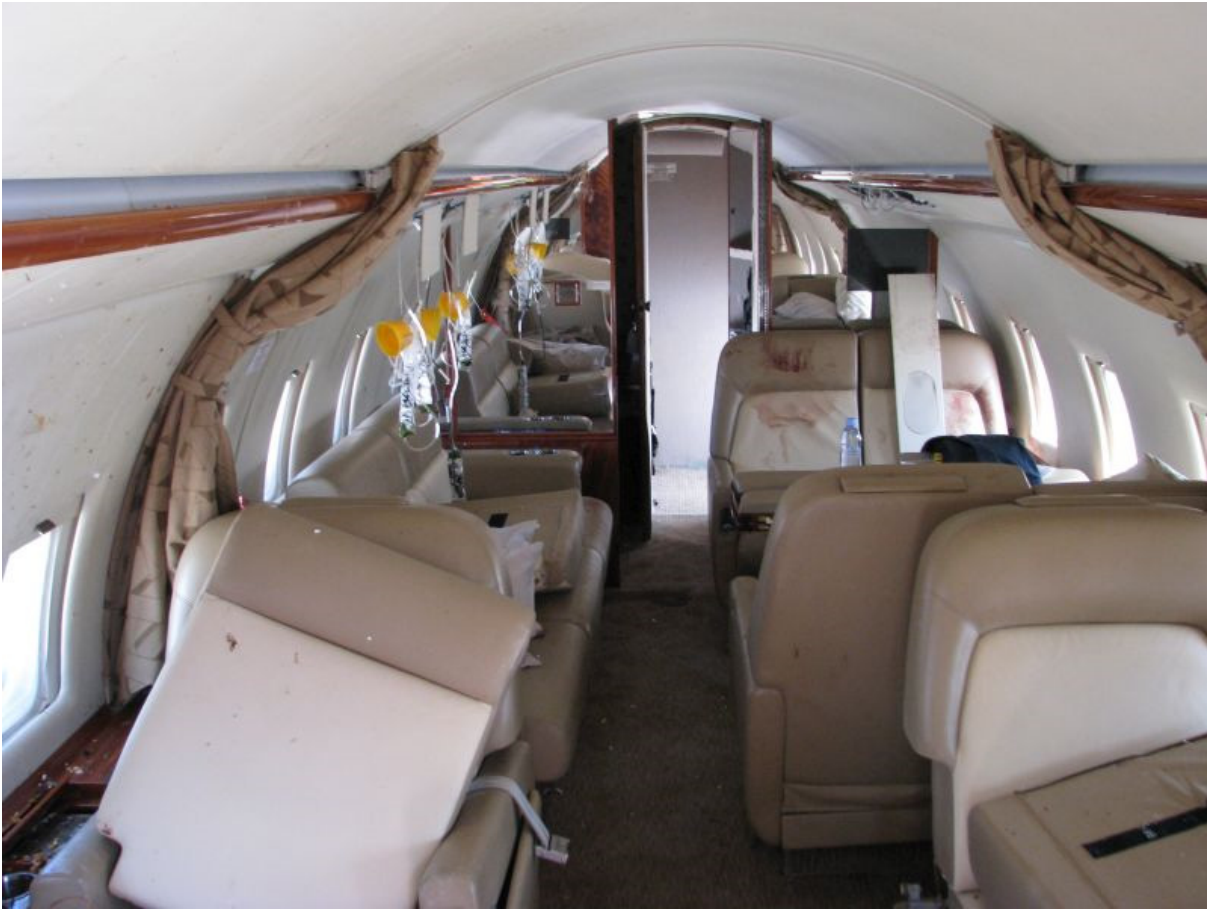
Damages in the cabin (viewed opposite to the direction of flight)

The inside of the passenger cabin showed damages on the seats and the panelling, as well as traces of blood. The armrests of the four seats in the front, installed in club arrangement, were either deformed or had fractured.

On the left side of the cabin two oxygen masks had fallen from their casings.

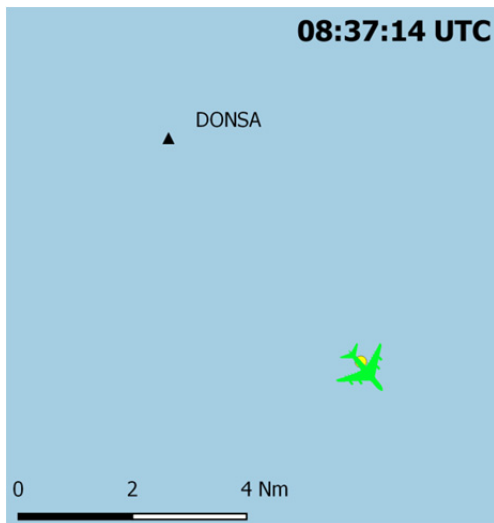
At about 0837:14 UTC the A380 passed at FL350 the position, where later the CL604 was subject to temporary loss of control.

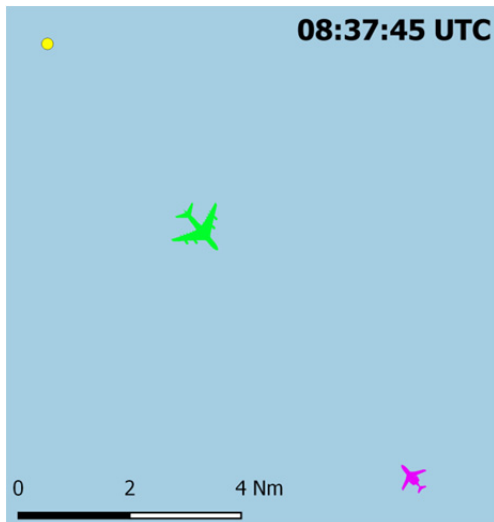
At about 0837:45 UTC the A380 TCAS captured the CL604 on opposite track (TCAS message proximate). At that time the distance between the two aircraft was 6 NM and 1,000 ft vertical.

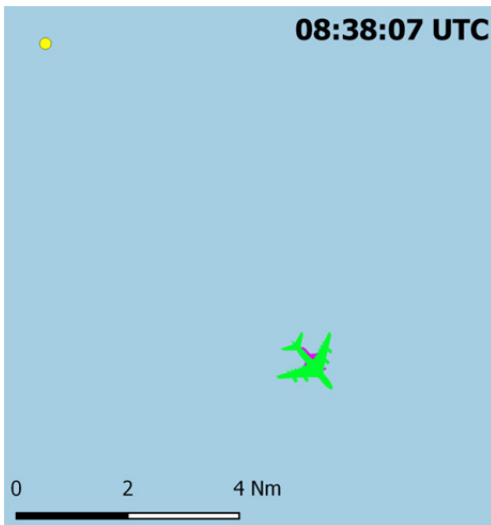
At about 0838:07 UTC the A380 passed the CL604 overhead with a vertical distance of 1,000 ft slightly to the right.

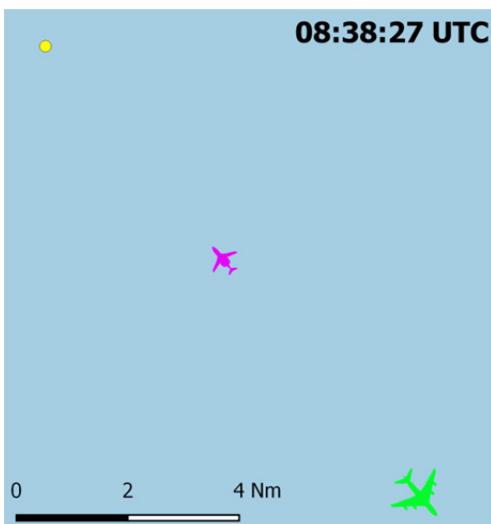
At about 0838:27 UTC the two aircraft left the capture area of their respective TCAS (TCAS message proximate). At that time the distance between the two aircraft was about 6 NM.

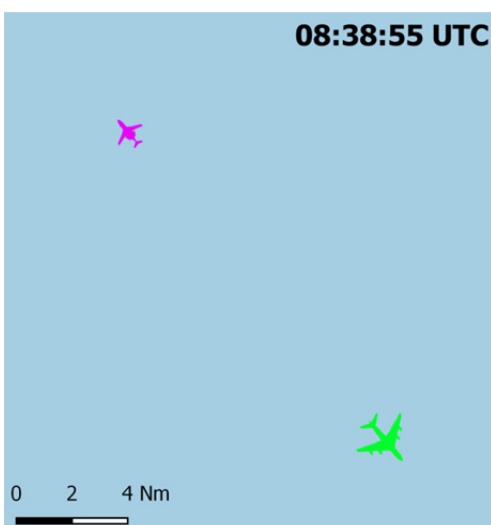
At about 0838:55 UTC at FL340 the CL604 encountered the wake vortex. At that time the A380 was about 15 NM south-east.

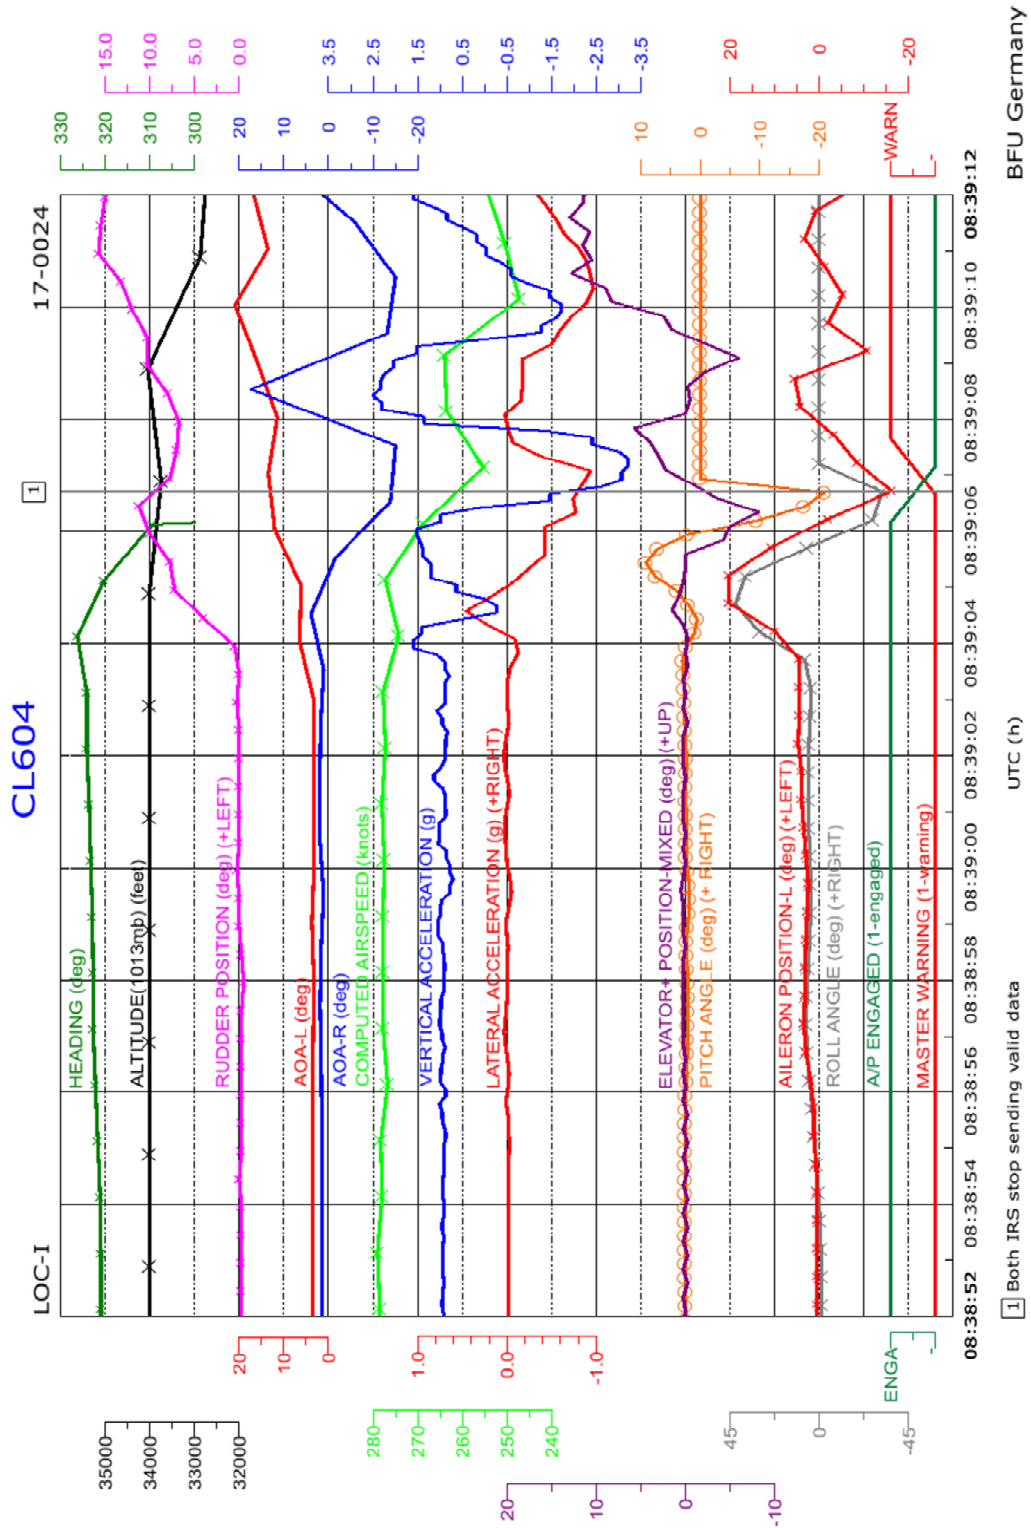
Excerpt of the CL604 FDR at the beginning of the occurrence

At 0838:54 UTC the CL604, with engaged autopilot, began to slightly roll right. At the same time a counter-rotating aileron deflection was recorded and fluctuation of the vertical acceleration began. In the subsequent approximately 10 seconds the airplane had a right bank angle of 4° to 6°. At 0839:03 UTC the right bank angle

began to increase. Within one second the bank angle increased to 42° to the right. At the same time the aileron deflection to the left increased to 20° and the vertical acceleration to 1.6 g. In the following second vertical acceleration changed to -3.2 g.

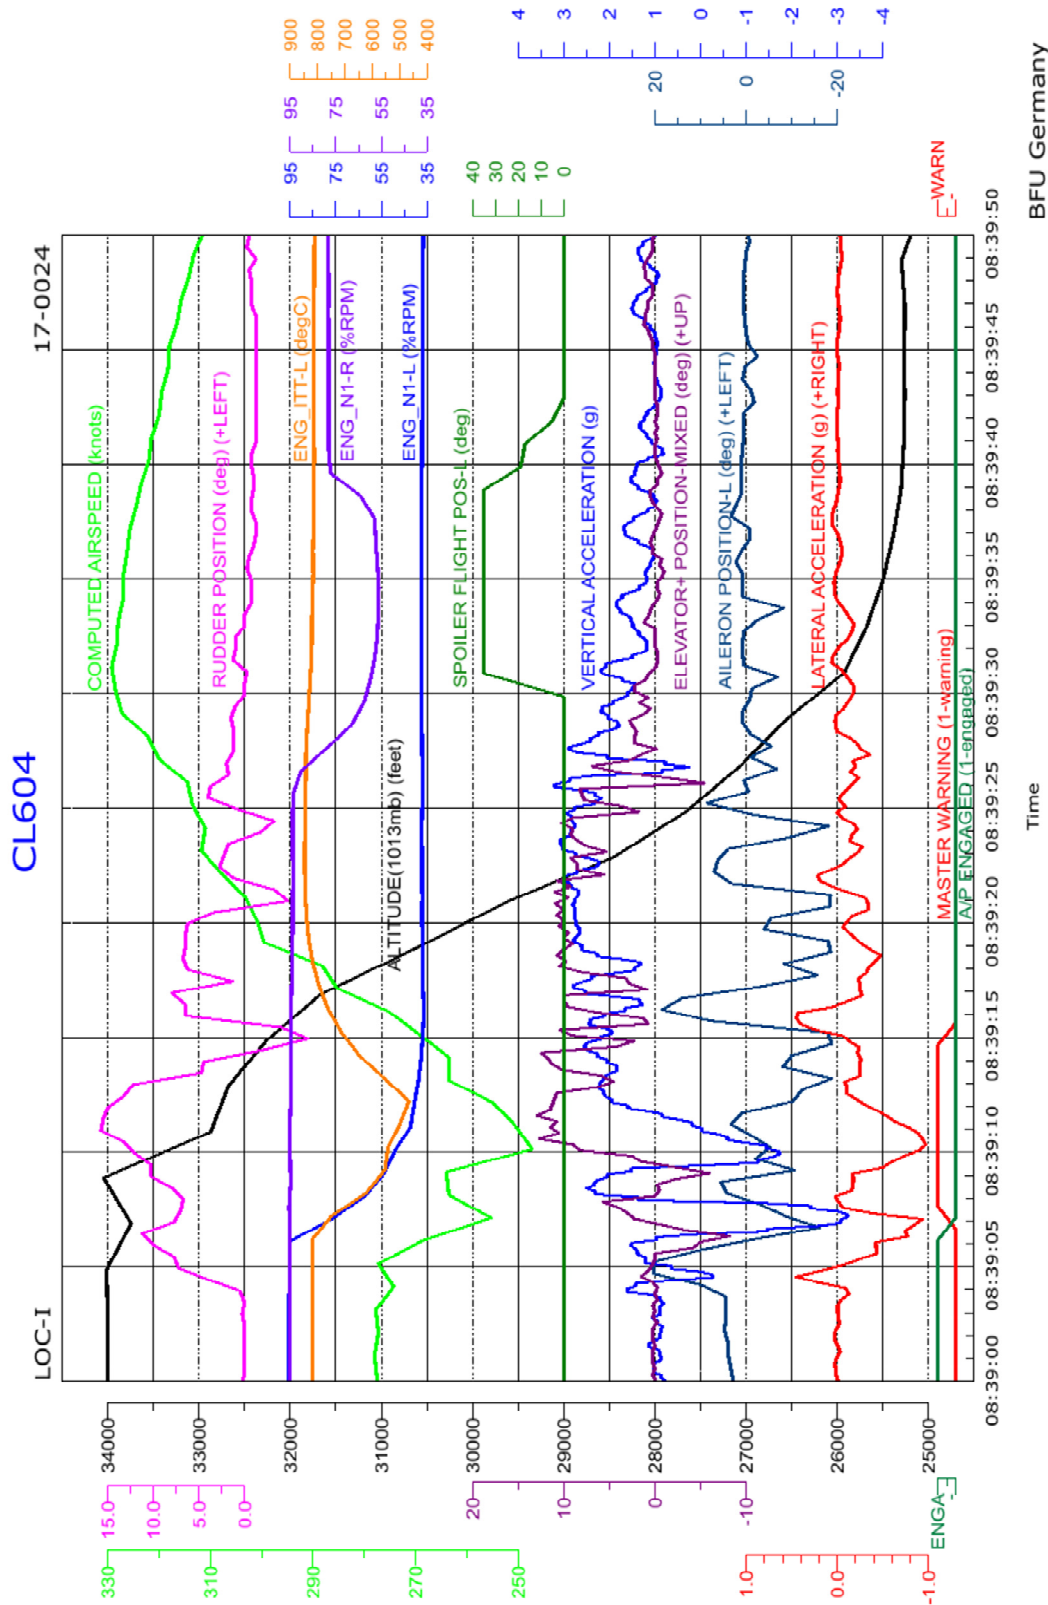
Excerpt of the CL604 FDR during altitude loss

Between 0839:09 UTC and 0839:41 UTC the FDR recorded a loss of altitude of approximately 8,700 ft. Large control surface deflections and acceleration were recorded. The speed increased and at 0839:31 UTC reached approximately 330 KIAS. At 0839:30 UTC the spoilers extended and 13 seconds later were retracted again. The N1 of the left engine had decreased to approximately 40% when the Interstage Turbine Temperature (ITT) began to increase and nine seconds later had reached 850°. The left engine was shut off.

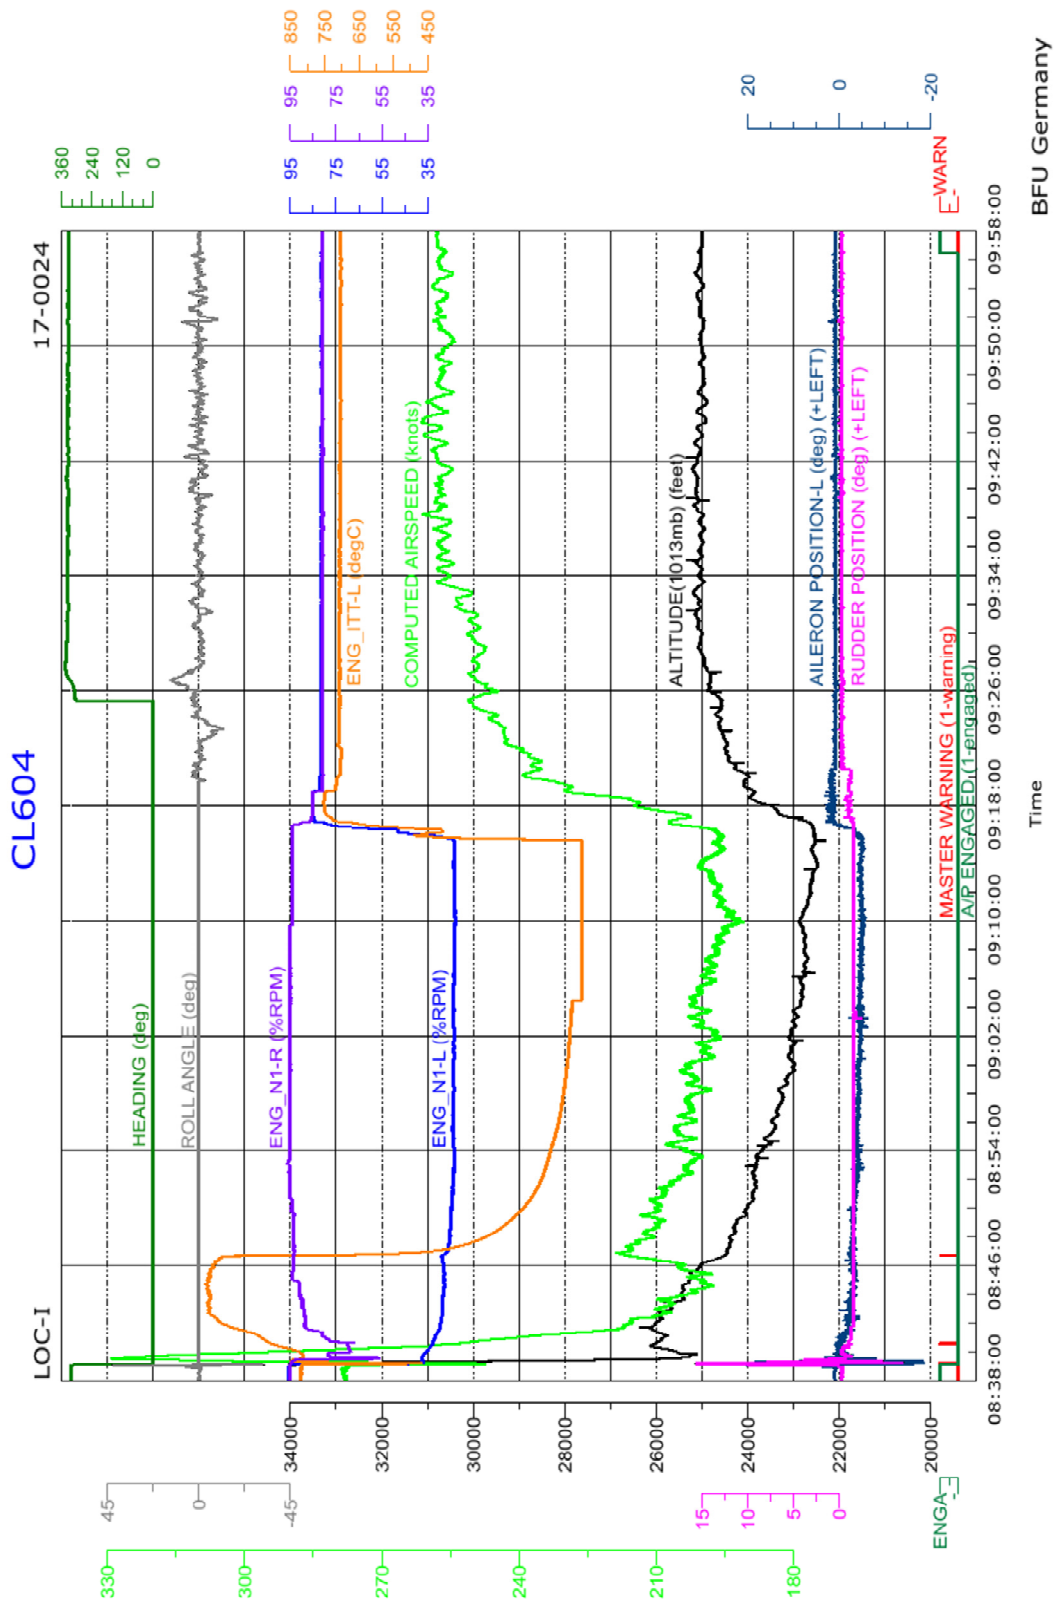
Excerpt of the CL604 FDR during recovery

At about 0915 UTC the crew restarted the left engine. Subsequently the airplane climbed to FL250. At about 0956 UTC the autopilot was re-engaged.
